# Repair Techniques for Celion/LARC-160 Graphite/Polyimide Composite Structures

J. S. Jones and S. R. Graves

CONTRACT NAS1-16448  
JUNE 1984

**J. S. Jones and S. R. Graves**  
*Rockwell International*  
*Downey, California*

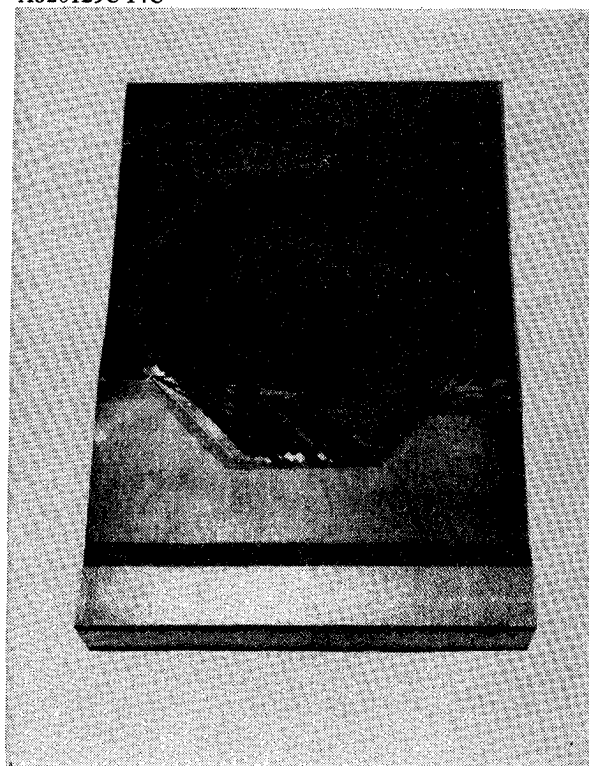
FAILURE MODE: SHEAR FAILURE UNDER PATCH AND SKIN COMPRESSION,  
ULTIMATE LOAD (LB/INCH): 8,282  
71.1% OF CONTROL

Figure 7-19. Heavily Loaded Sandwich Specimen Repair, EX483/483-1  
(0,  $\pm 45$ , 90)<sub>2s</sub> Transverse-Oriented Outer (0) Fibers--  
Failure Mode; 316°C (600°F) Test

Three repaired transverse oriented 0-degree outer fiber specimens were compression tested and joint efficiencies range between 75.7 and 90.6 percent of transverse-oriented fiber undamaged control specimens. Two specimens failed by combined shear-out of the repair patch and compression failure of the repair patch and parent laminate skin. The third and highest load bearing specimen failed by parent laminate skin compression outside the repair area. Photographs showing specimens and modes of failure are presented in Figures 7-17, 7-18, and 7-19.

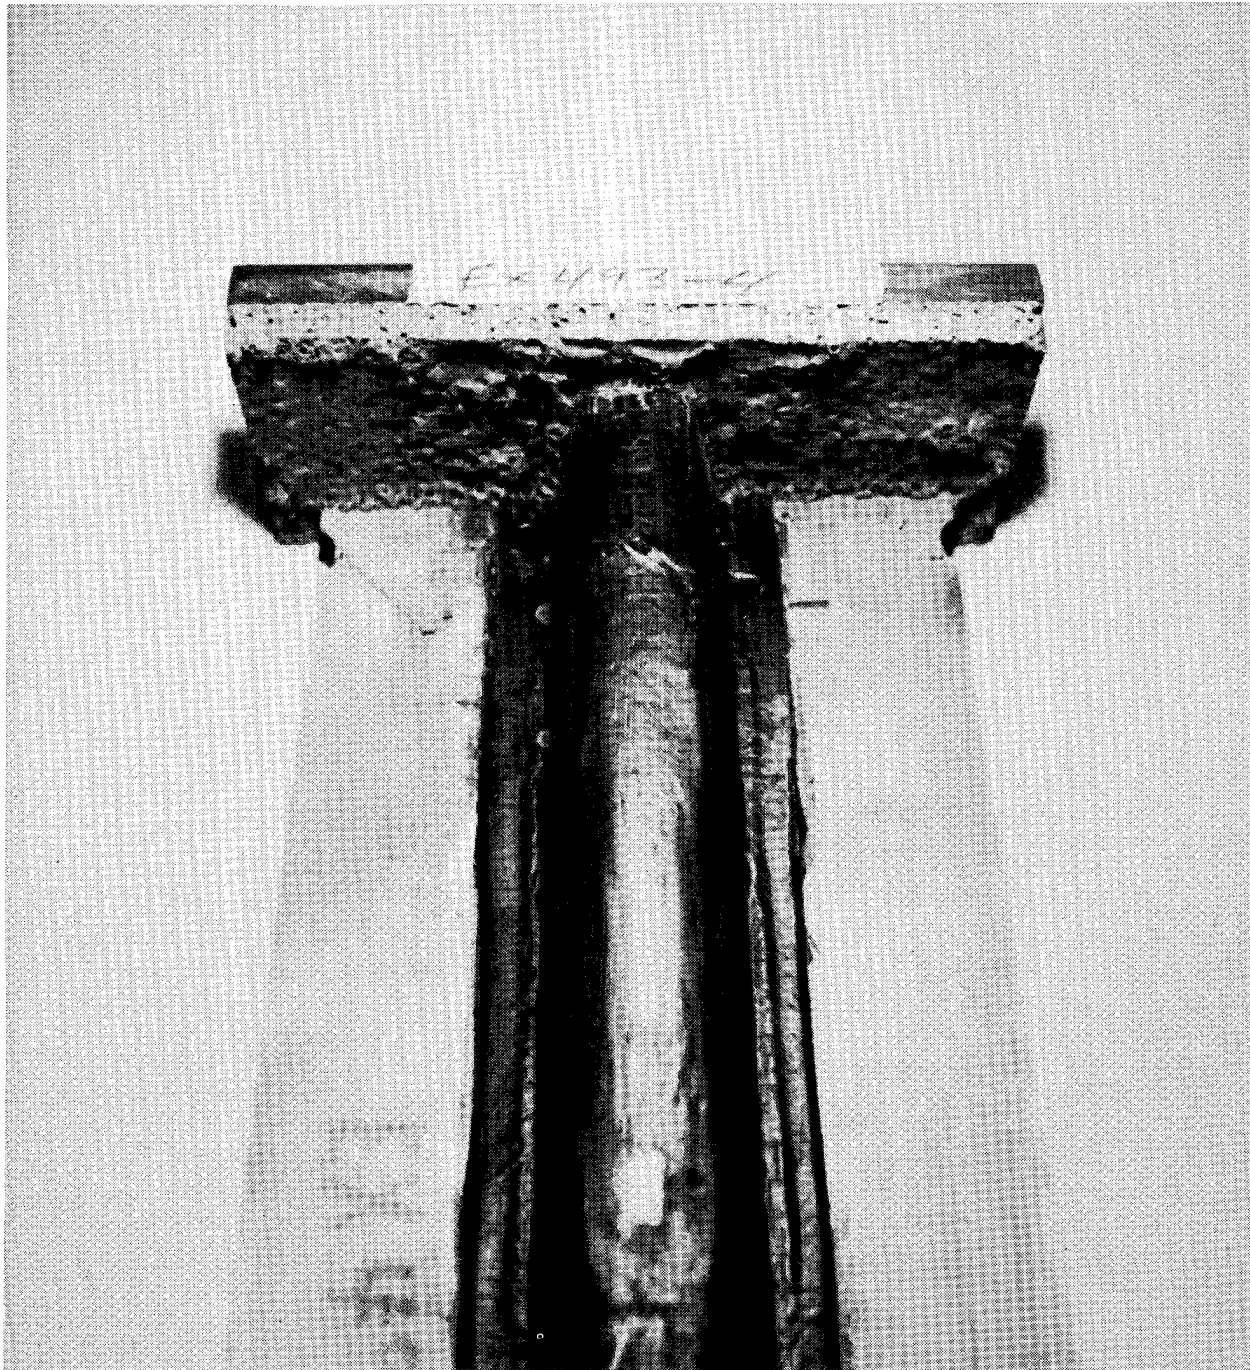
Figure 8-25. Failure Mode of Heavily Loaded Repaired Hat Stringer Element Tested at 316°C (600°F)

The typical load-strain responses at room temperature and 316°C (600°F) for the repaired heavily loaded hat-stiffened panels are presented in Figure 8-24, and the 316°C (600°F) failure mode is presented in Figure 8-25. Referring to the response of the specimen tested at room temperature, the strain in the cap (gage 1) is somewhat larger than in the skin (gage 2), indicating that the specimen was not placed precisely square in the test fixture. This could result in premature failure in the cap. The load transfer into the patch is shown by strain gages 3 and 4. Strains are about 17 percent higher at the edge of the patch than 2.54 cm (1.0 in.) from the edge. During the elevated temperature test, the cap and skin were strain balanced, but this particular specimen failed at 58 percent of the room temperature repair strength, although it was outside the repaired section.
